Affected zone generated around the erosion pit on carbon steel surface at the incipient stage of vibration cavitation

CHEN HaoSheng^{1†}, LI Jiang², LIU ShiHan¹, CHEN DaRong¹ & WANG JiaDao¹

¹ State Key Laboratory of Tribology, Tsinghua University, Beijing 100084, China;

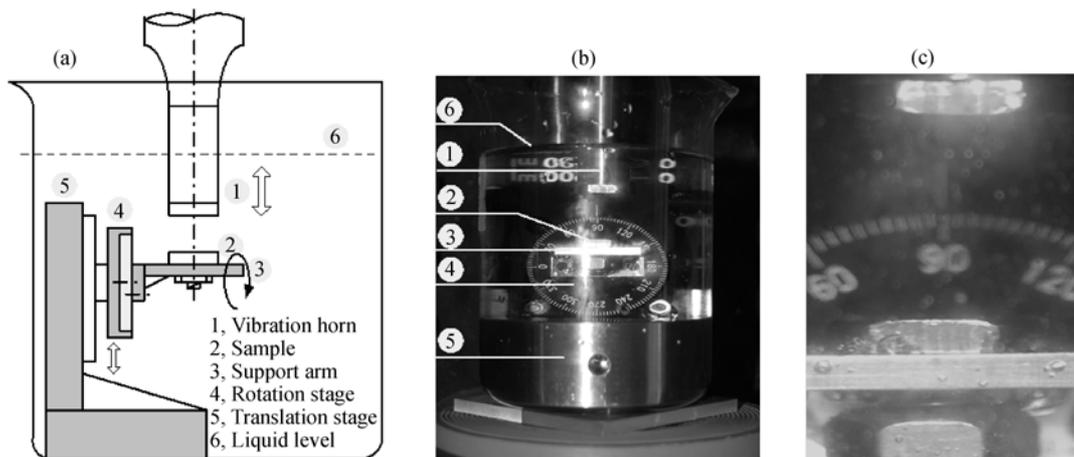
Figure 1 (a) Schematics of the vibration cavitation apparatus; (b) the picture of the apparatus and (c) picture of the system in operation showing cavitation cloud.

Figure 1(a) shows the schematic of an ultrasonic vibration cavitation apparatus used in the experiment. The vibration horn performs an axial vibration with a frequency of 20 kHz and an amplitude of 6 μm . The sample piece is installed on the support arm of a two-dimensional table, and the testing surface faces the tip of the vibration horn. The interval between them is adjusted by the translation stage, while the pitch angle of the sample surface is adjusted by the rotation stage. During this experiment, the distance between the two faces was 15 mm. The experiment is performed in a beaker filled with de-ionized water. Figure 1(b) and (c) show the system before and during the experiment, respectively.

The experiment lasted 5 min. The reason for such a short time was to reduce other damages such as corrosion and abrasion. The cavitation phenomena captured by a digital camera is shown in Figure 1(c). A clear cavitation domain is found near the vibration horn's tip, and some bubbles are seen rushing to the sample surface. Scanning Electron Microscope (SEM, Quanta 200 FEG, FEI Co.) pictures in Figure 3 show the erosion pits on the sample surface with the magnitudes of 300, 2000, and 20000, respectively. It is found in Figure 3(a) that

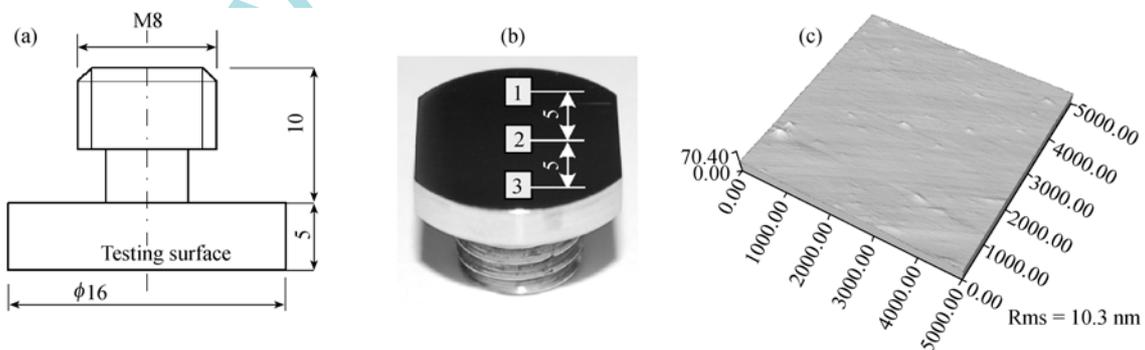
Figure 2 Sample and the tested surface profile. (a) Sample dimension; (b) sample picture; (c) tested sample surface.

The sample is designed according to the Chinese standard (GB6383-86) on a vibration cavitation erosion system, and its dimension is shown in Figure 2(a). The sample is made of a medium carbon steel (0.45% car-

bon), whose yield point is higher than 680 MPa. The sample surface is polished, and the root mean square (Rms) value of the surface roughness is 12.5 nm, which is tested by an Atomic Force Microscope (AFM) CSPM 4000. It should be noted here that there are three measuring regions on the sample surface marked as 1–3 in Figure 2(b). The size of each region is 5 μm \times 5 μm , and the surface roughness of the sample surface is the mean value of the surface roughness measured in the three regions. Figure 2(c) shows one of the tested regions.

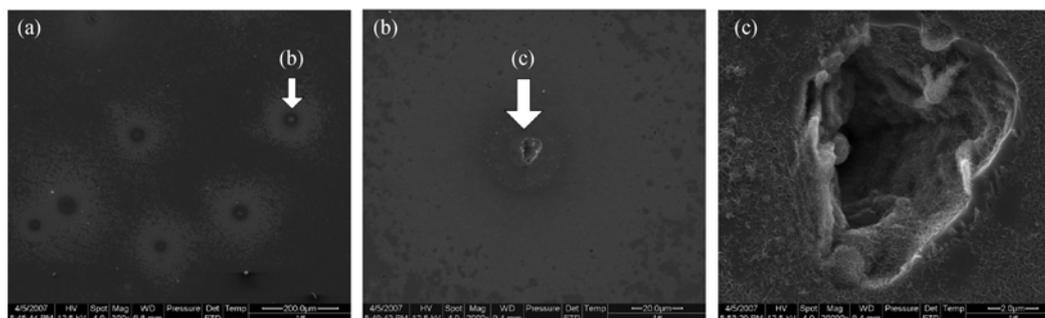
Figure 3 Erosion pits on the sample surface observed by SEM after the experiment with magnitudes of (a) 300, (b) 2000 and (c) 20000.

the erosion pits scatter on the sample surface, and they have two main characteristics:

(i) The pit is deep and small as shown in Figure 3(c), and it is usually called a needle-like pit. It is a characteristic phenomenon appearing at the incipient stage of the cavitation erosion as described by Hammit^[1], and it is considered as the result of a micro-jet impacting on the surface at the moment of the bubble collapse.

(ii) As shown in Figure 3 (a) and (b), an obvious affected zone in deep color can be seen around each erosion pit. An erosion pit with an obvious affected zone was chosen and observed by an Olympus LEXT OLS3100 confocal laser scanning microscope. In Figure 4, the affected zone surrounded the erosion pit has a distinguished round shape. The continuous line represents the surface profile of the surface at the cross-section marked by the dashed line. The line is across the center of the erosion pit, and the surface profile shows both the shapes of the pit and of the affected zone. The erosion pit is narrow and deep, while the affected zone is obviously raised from the base, whose shape looks like the rise ring on the aluminum surface in the erosion experiment done by Knapp^[8]. The affected zone is believed to

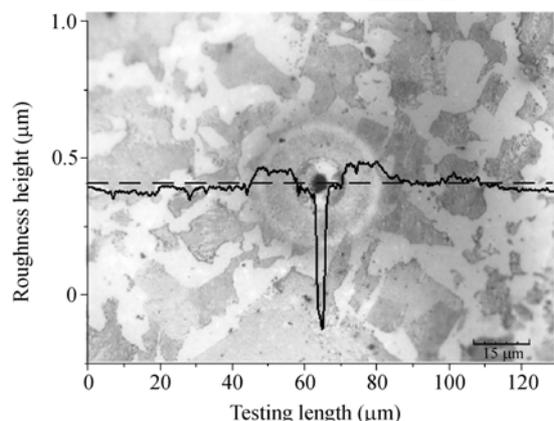
Figure 4 Surface profile of the erosion pit with the affected zone tested by the confocal laser scanning microscope.

Another important phenomenon is that the affected zone appearing in the optical microscope is colorful. Moreover, as shown in Figure 4 and Figure 5(a), the color of the surface at the edge of the zone changes from red to blue gradually. The appearance of the iridescent color indicates that the temperature on the steel surface may reach 300°C according to the experiment of Wang et al.^[10]. In addition, it is known that the hardness of the medium carbon steel decreases when the steel is tempered at the temperature higher than 300°C. So, the iridescent color and the decreased surface hardness both indicate that the affected zone has experienced a high temperature tempering process.

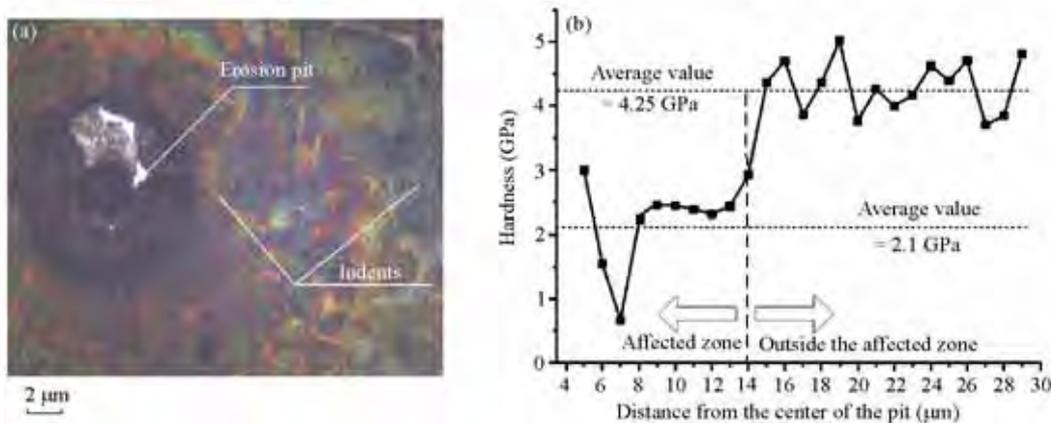
Figure 5 Surface hardness testing. (a) is the pit with indents; (b) is the hardness in and outside the affected zone.

The hardness of the affected zone was tested by a Nano Tester (MML Co.). 25 indents were made on the sample surface outside the pit along the radius direction, which are shown in Figure 5(a). The interval between the two indents is 1 μm. The maximum indent depth is 800 nm, and the maximum load is 20 mN. The hardness of the surface within and outside the affected zone is shown in Figure 5(b). It is found that the average value of the hardness in the affected zone is approximate half of that outside the affected zone.

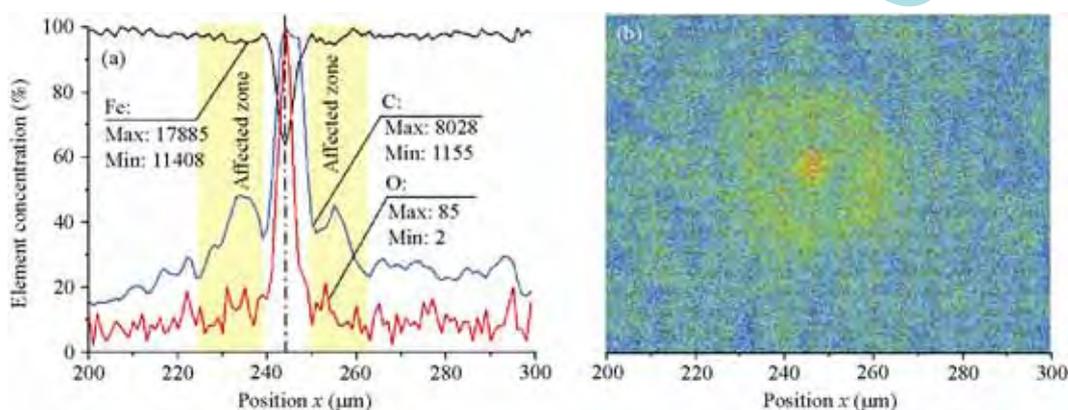
Figure 6 The elemental composition of surface materials tested by an EPMA-1600 electronic probe. (a) The line scan results of Fe, C and O; (b) the area scan result of carbon.

oxygen within the affected zone were detected. The concentrations of the three different elements are shown in Figure 6(a) using line scan along the horizontal diametric line. The Y axis represents the percentage of each element compared with its maximum atom counts, while the numbers marked in the figure are the true maximum and minimum atom counts for each element.

Two main phenomena are found from the detected results. First, in the erosion pit, the Ferro concentrations decrease while the concentrations of carbon and oxygen increase. Second, the carbon concentration in the affected zone obviously increases although such a concentration is much lower than that in the erosion pit. This phenomenon can be seen more clearly in Figure 6(b). In Figure 6(b), the distribution of the carbon on the damaged surface is tested using the area scan method, where the concentration is represented by the color. Besides the carbon aggregation in the erosion pit, the carbon also forms a ring in the affected zone, which is called the 'carbon ring' here. It is proved now that the carbon and
